METALLURGICAL EXAMINATION OF A DAMAGED V-22 HYDRAULIC LINE

1 SEPTEMBER 1995

FINAL REPORT

9. SPONSORING / MONITORING AGENCY NAME(S) AND ADDRESS(ES) **Air Vehicle Department Materials Division (Code 4.3.4.2) NAVAL AIR WARFARE CENTER; AIRCRAFT DIVISION WARMINSTER P.O. Box 5152 Warminster, PA 18974-0591			10. SPONSORING / MONITORING AGENCY REPORT NUMBER NAWCADWAR-95045-4.3

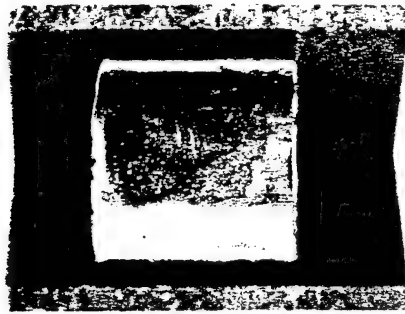
Figure 1: A Polaroid photograph of the excised damaged section of the V-22 Hydraulic Line.
Magnification = 1X.

A macroscopic image of the damaged portion of the hydraulic line is presented in **Figure 1**. The damage is localized to the contact area of the rubber clamp: approximately 0.5 inches wide that extends around the exterior circumference of the tube. This area could be described as a rough discolored surface containing small shallow pits (some with darkened areas) and scratches. In addition, the contact area of the rubber clamp was found to contain a black gritty material.

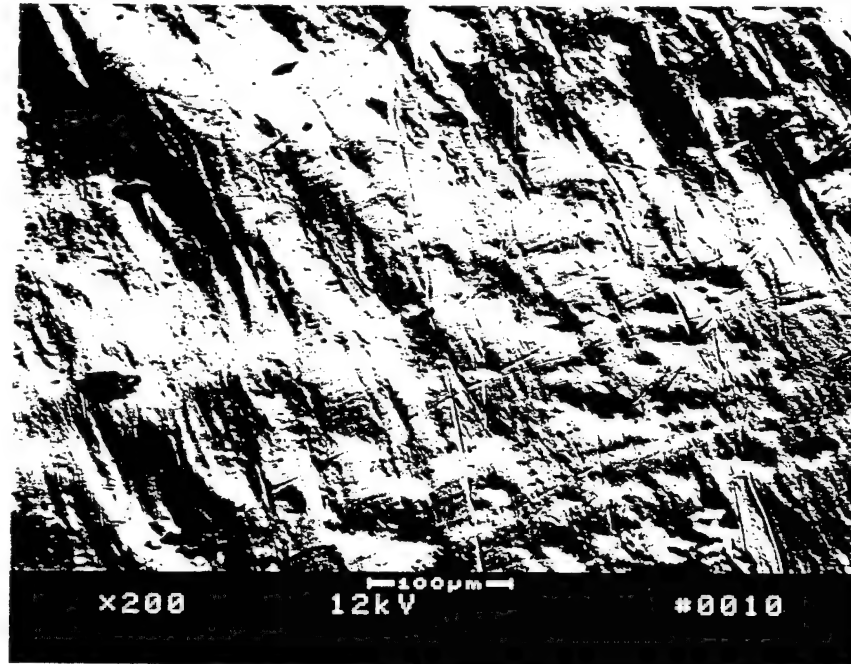
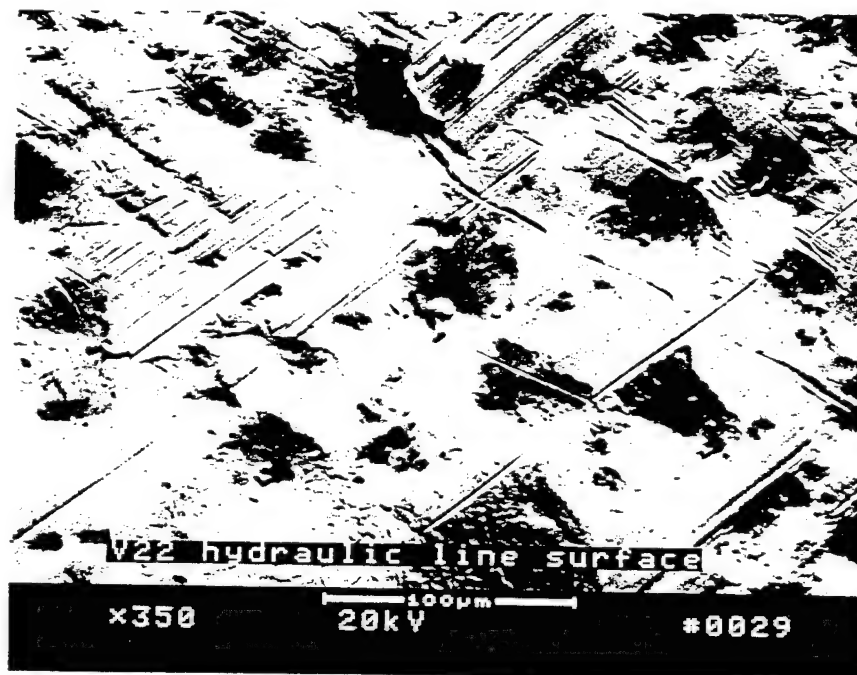
Figure 2: SEM micrographs of the damaged surface of the V-22 Hydraulic Line (as-received).

The surface of the damaged tube was observed to be pitted with an indication of abrasion, **Figure 2**. There was a bimodal distribution of pit sizes. The larger pits were rounded with scratches running through them. The smaller pits were more clearly defined with sharp edges. Generally, the surface of the tube was free of oxides and other corrosion products (e.g. titanium hydrates). Upon close examination of the pitted areas, a second phase of particles was found. EDS results of these second phase products are displayed in **Figures 5 and 6**, indicating a presence of Al and O. However, only constituent elements of Ti-3Al-2.5V were detected in the cross-sectional area of the damaged tube, as shown in the spectrum of **Figure 7**.

The directionality of the pits seen on the surface of the damaged tube, as shown in **Figure 2**, tends to imply some type of abrasion due to mechanical means. In addition, after metallographical preparation of the transverse section of the damaged area, no alteration in microstructure was detected; despite the existence of minor surface damage - depressions, as seen in **Figure 4**. Therefore, no microstructural indication of corrosion was present; but there was evidence of good texture control of the tubing (**Figure 3**). In general, the surface topography of

the damaged hydraulic line tended to resemble those that are caused by classic cases of fretting, more particular to its early onset.

The evidence suggests that the damage done to the V-22 hydraulic line was from the cyclical and vibratory motion of very small foreign particulates, obtained from the surroundings, that became embedded in and between the surfaces of the tube and of the contacting rubber clamp. Elimination of these contaminants would smoothen the contact surfaces and prevent any premature damage of this pump suction tube from occurring and/or recurring.

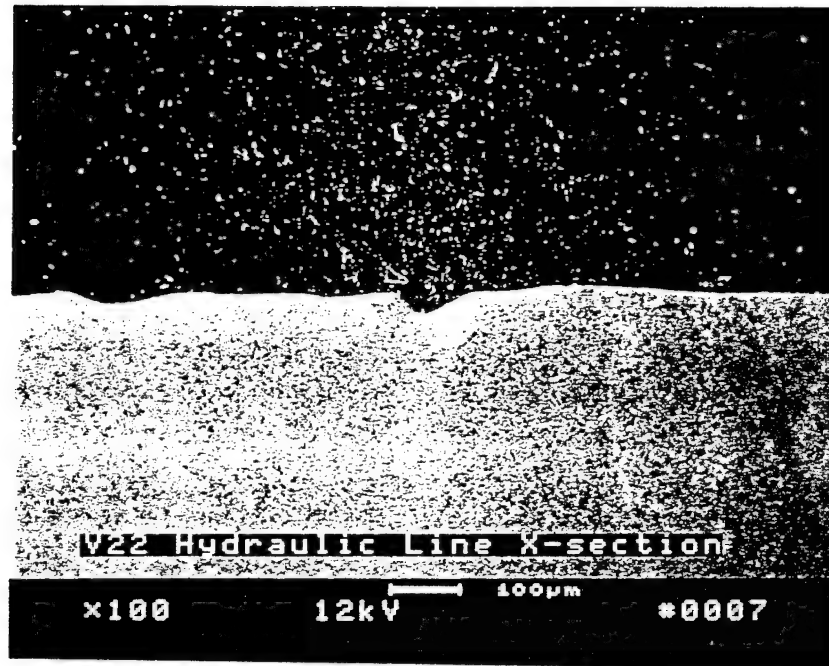
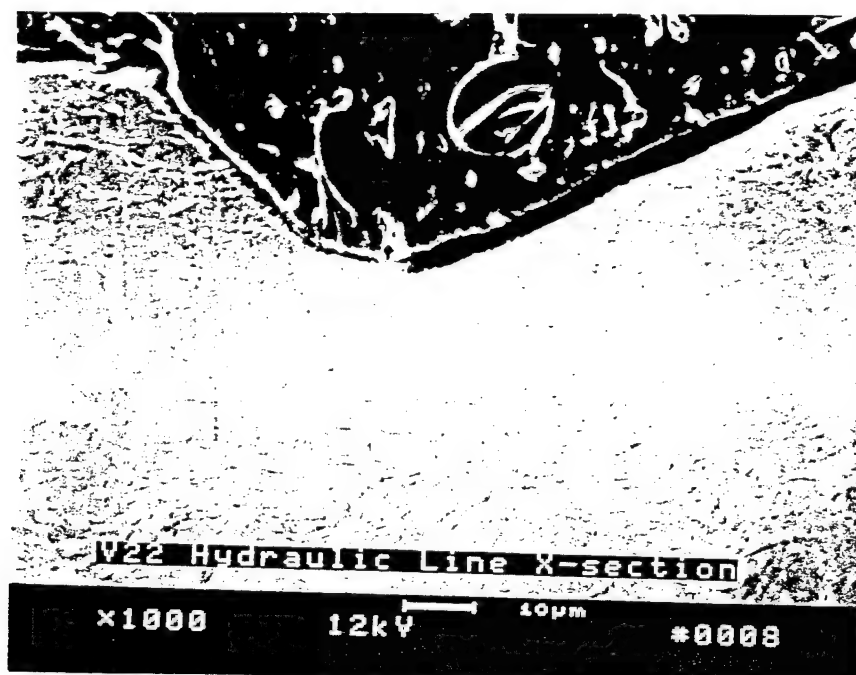
Figure 3: SEM micrographs of the damaged cross-section of the V-22 Hydraulic Line.
Samples were polished and etched in Kroel's reagent (3:1).

Figures 2 and 3 are SEM micrographs of the damaged surface and the corresponding cross-section of the pump suction tube (as-received). Pits and gouges were detected on the surface; no evidence of cracking and intergranular attack was found. However, there was some directionality observed with the orientation of some pits. These particular pits were aligned as if created by some mechanical means. The micrographs also reveal a fine grained, oriented alpha-beta microstructure, in which the alpha is observed as the lighter phase dispersed in the darker beta matrix.

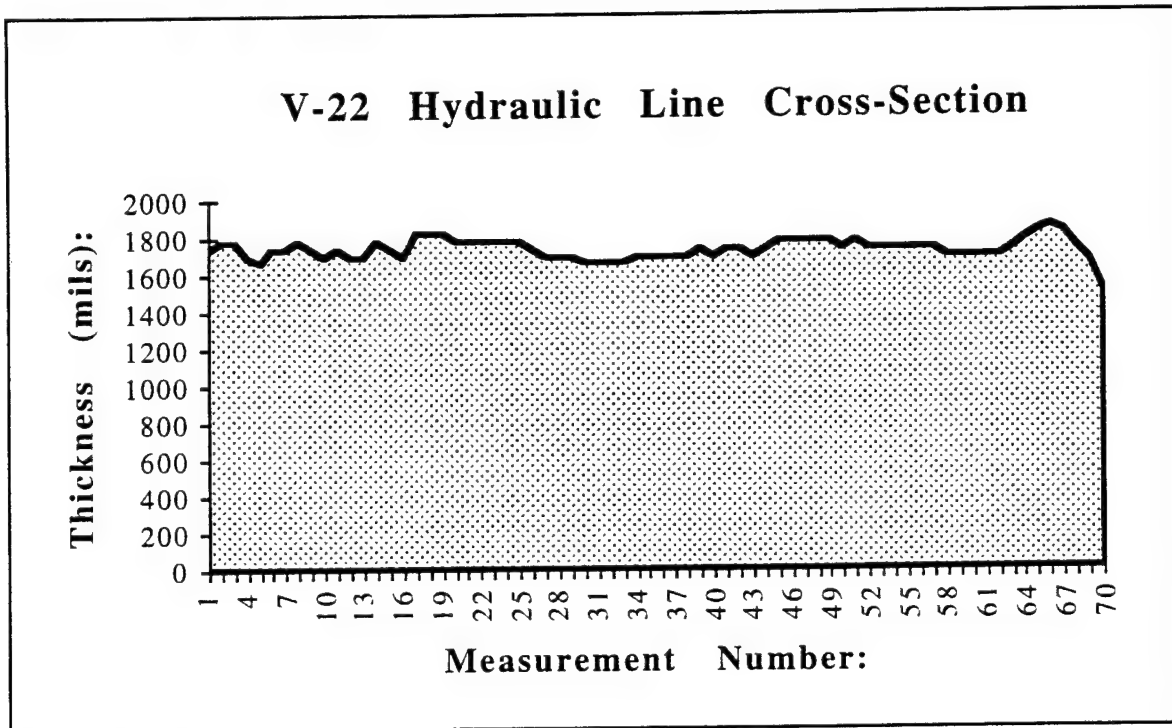
Figure 4: A compiled cross-section of the damaged V-22 Hydraulic Line obtained with linear measurements taken from optical micrographs of the entire cross-section.
(An example of a photographed cross-sectional area is shown below.)

A profile of a representative cross-section of the damaged tube is portrayed in **Figure 4**. This was constructed from a compilation of linear measurements of the damaged tube's cross-section taken from optical micrographs (of which an example is also included in **Figure 4**). A maximum pit depth was measured to be approximately 30 mils (0.07 cm). The average thickness of the V-22 hydraulic line was determined to be 1750 mils (4.45 cm) with a standard deviation of 50 mils (0.13 cm).

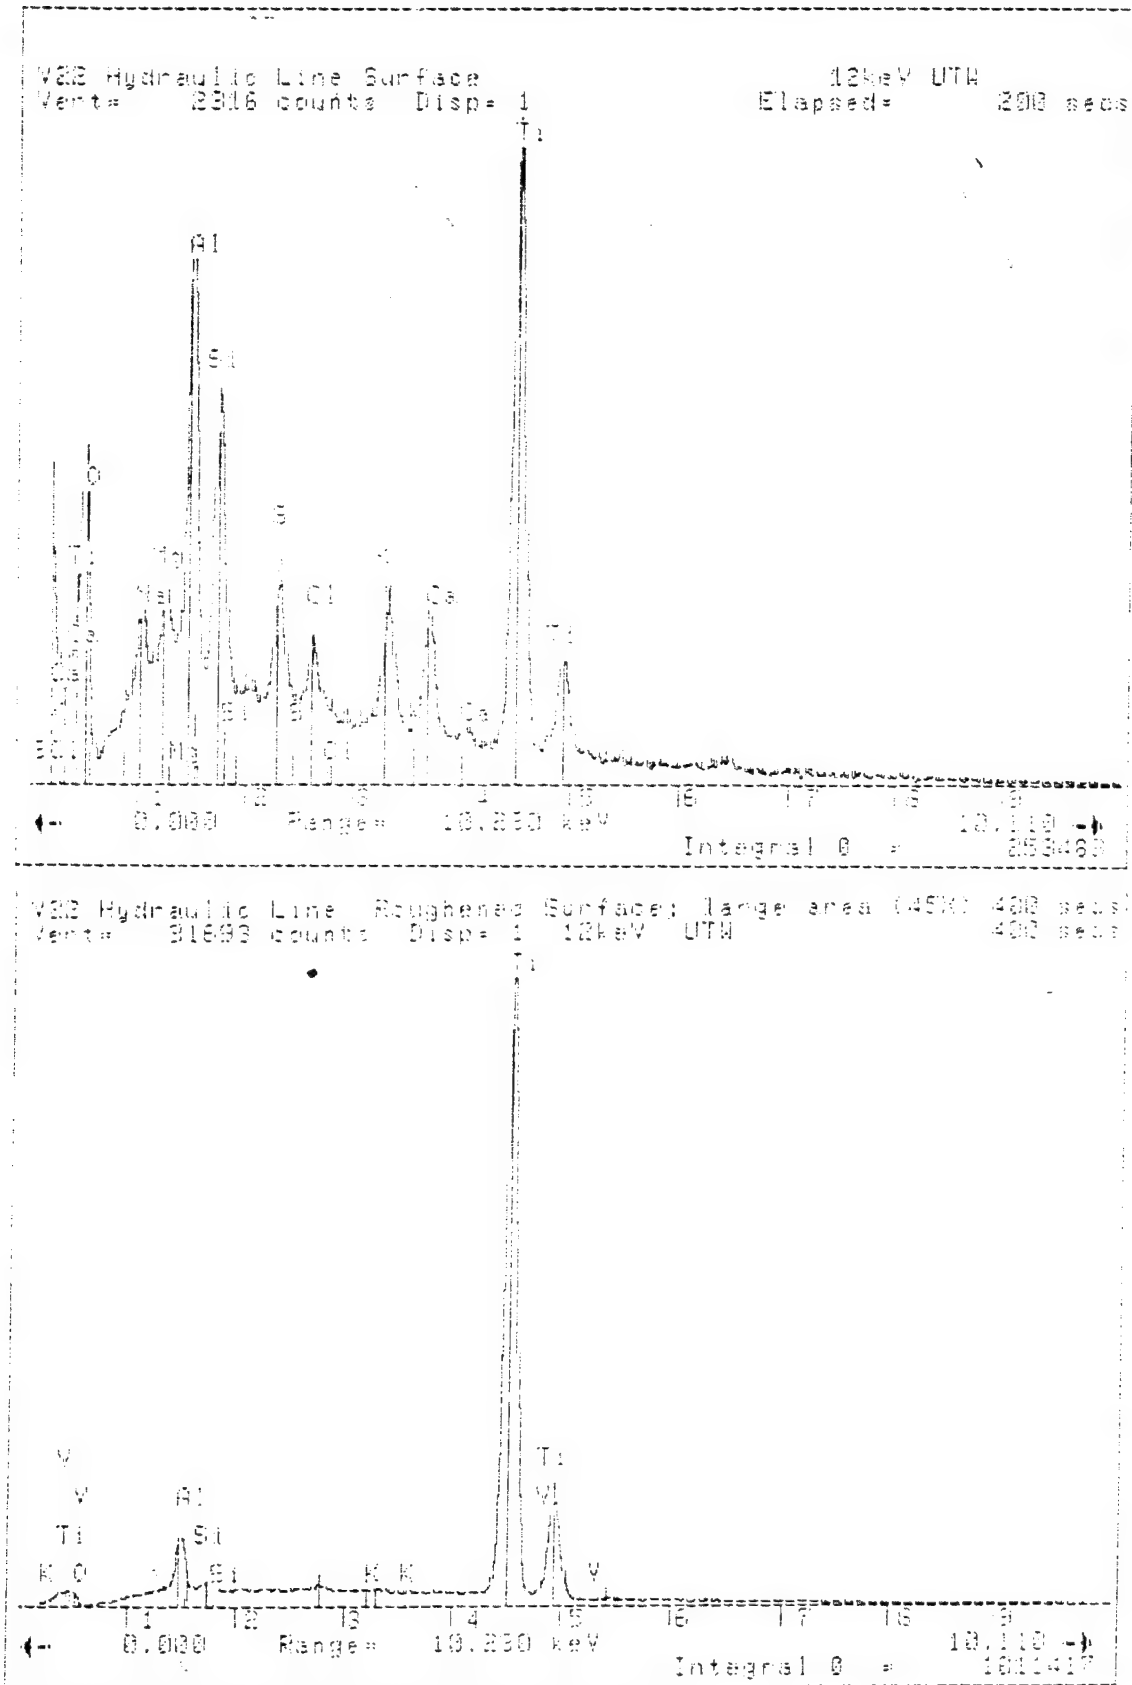
Figure 5: Elemental analyses (EDS) of the damaged surface of the V-22 Hydraulic Line.

Elemental analyses (EDS) had shown a large quantity of foreign elements present in both the damaged area (surface) of the tube and its connecting rubber clamp, but not in its corresponding cross-section, **Figures 6-10**. Yet, there was no evidence of any corrosion by-products. However, identifying the foreign particulates as largely sand (SiO_2) and alumina (Al_2O_3), as seen from the resulting spectra of **Figures 6 and 8** respectively, had suggested that it was most likely the hostile environment that this piece of suction tube was subjected to that led to the contamination of the contact areas of its surface and of the rubber clamp; thereby created the damage observed. This was also verified from the two similar spectra obtained of the darkened areas on the pitted surface and on the rubber clamp, **Figures 9 and 10**.

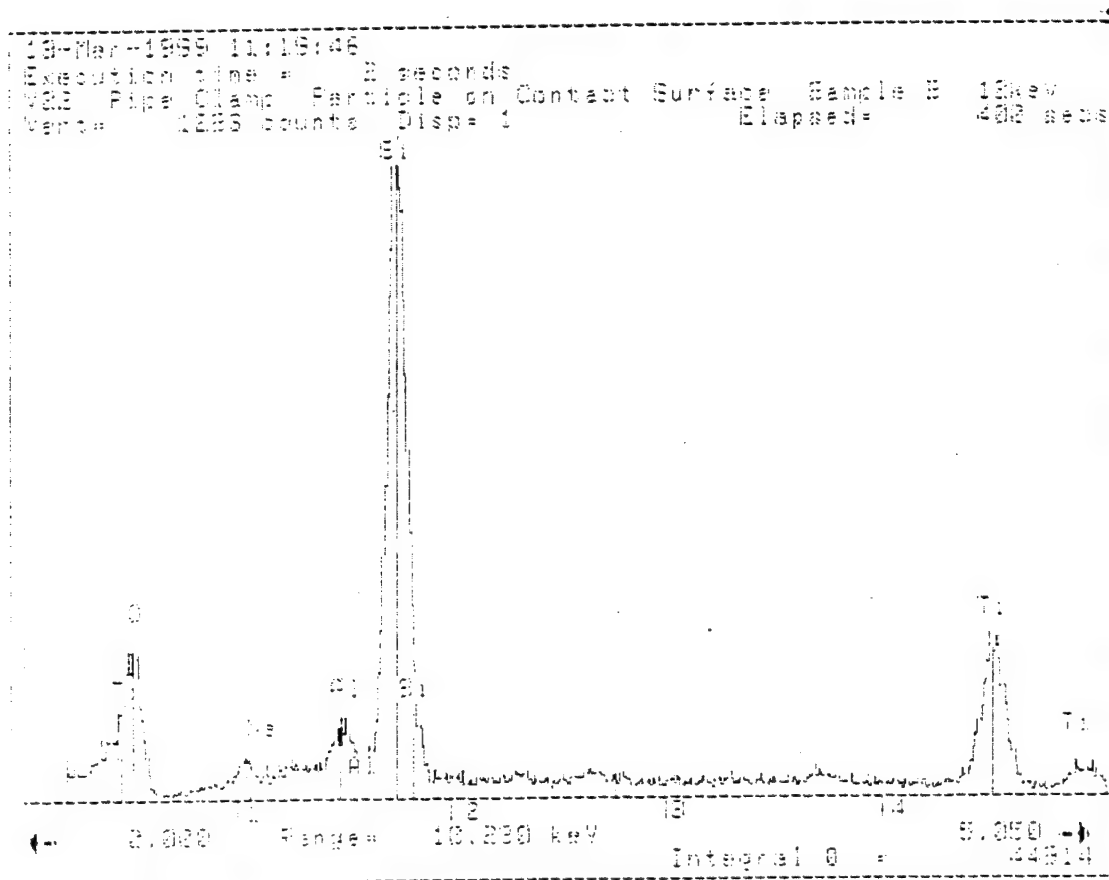
Figure 8: Elemental analysis (EDS) of the rubber clamp's surface that was in contact with the damaged V-22 Hydraulic Line.

With regard to the corresponding contact area of the rubber clamp, large peaks of Si and O were identified by EDS (**Figure 8**). Furthermore, the black gritty area of the clamp, when compared to the nascent rubber, was discovered to contain large peaks of C, Na, O, and S with an additional presence of Ca and K (**Figure 9**). This result is similar to the EDS spectrum of the darkened pit areas of the tube (**Figure 10**).
